# **NovaSeq Software Release Notes**

**NovaSeq Control Software 1.7.0**  
**NovaSeq Service Software 1.7.0**  
**Real Time Analysis 3.4.4**  
**Universal Copy Service 1.6.3**  
**Install notes**

**July 2020**

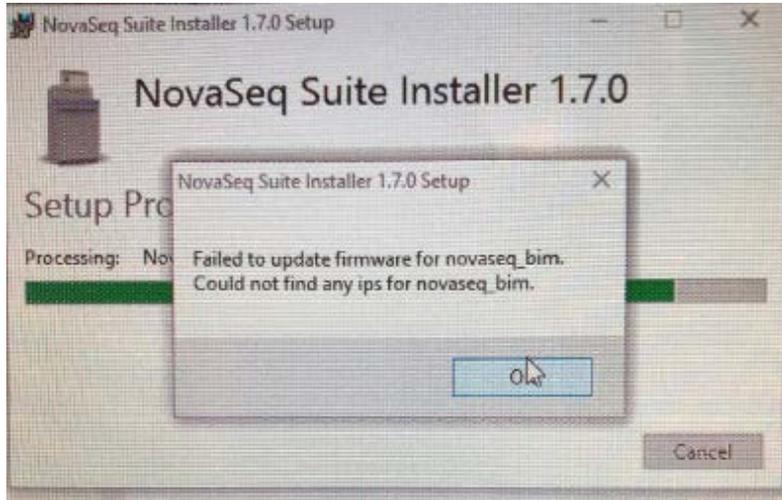
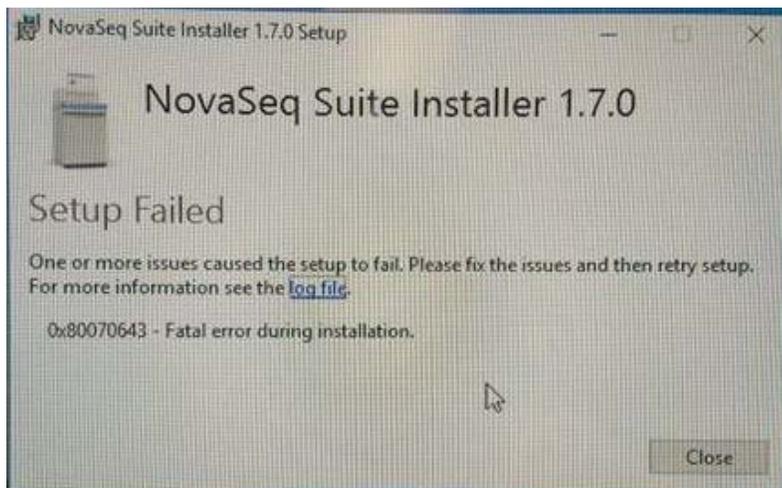
- On rare occasions, the installer can fail to communicate with one of the devices on the system in the required time, resulting an error message (below) and the software update process will not complete

- If seen, please run the installer package again.
  - If successful, please perform the full power cycle as documented on page 4
  - If the issue persists, please call technical support for next steps.
- If encountering this issue via BSSH download, please call technical support for next steps
